DEPARTMENT OF TRANSPORTATION

Office of Structural Materials

Contract #: 04-0120F4Cty: SF/ALA Rte: 80 PM: 13.2/13.9File #: 69.28**WELDING INSPECTION REPORT****Resident Engineer:** Pursell, Gary**Address:** 333 Burma Road**City:** Oakland, CA 94607**Report No:** WIR-010401**Date Inspected:** 19-Nov-2009**Project Name:** SAS Superstructure**OSM Arrival Time:** 700**Prime Contractor:** American Bridge/Fluor Enterprises, a JV**OSM Departure Time:** 1900**Contractor:** Zhenhua Port Machinery Company, Ltd (ZPMC), Changxing Island **Location:** Shanghai, China**CWI Name:** Chen Xi**CWI Present:** Yes No**Inspected CWI report:** Yes No N/A**Rod Oven in Use:** Yes No N/A**Electrode to specification:** Yes No N/A**Weld Procedures Followed:** Yes No N/A**Qualified Welders:** Yes No N/A**Verified Joint Fit-up:** Yes No N/A**Approved Drawings:** Yes No N/A**Approved WPS:** Yes No N/A**Delayed / Cancelled:** Yes No N/A**Bridge No:** 34-0006**Component:** Orthotropic Box Girder (OBG) Crossbeams**Summary of Items Observed:**

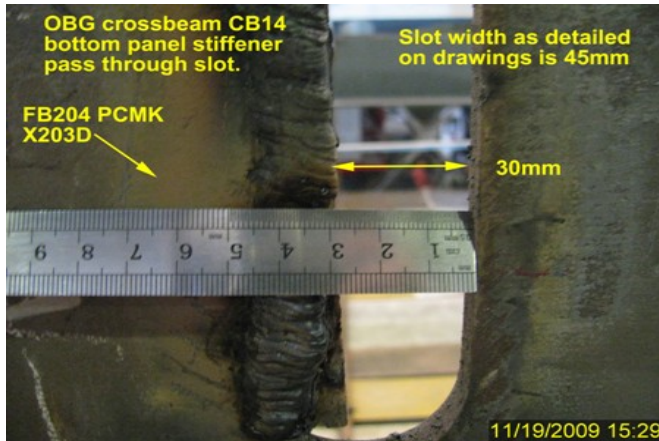
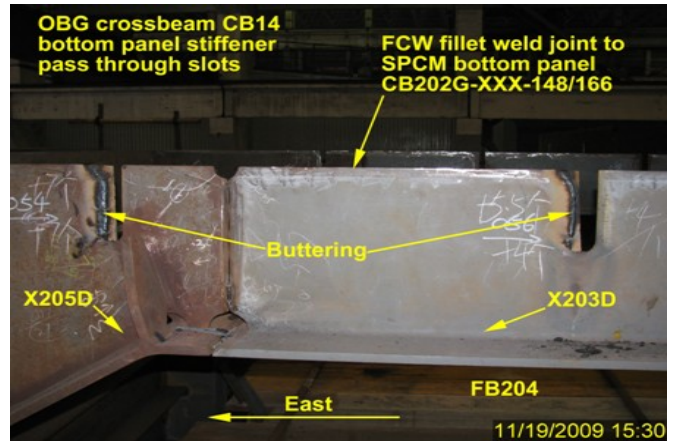
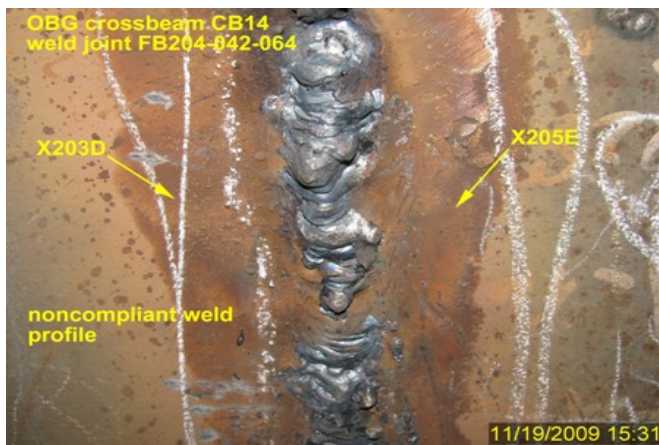
This QA observed ZPMC welding personnel Build Up With Weld (Buttering) one edge of the bottom panel stiffener pass through slots. The procedure being used does not indicate to perform Ultrasonic Testing of the repair area as specified in AWS D1.5 2002 section 3.7.7.1. The slots are located in the web plates of floor beam diaphragms identified as FB204 and FB205. Piece Mark (PCMK) numbers affected are X203D, X205E, X205D and X205F at all four diaphragm locations. Weld numbers affected are as follows: CB202G-041-055, 056, 057, 058, 061 and 062; CB202G-042-053~062; CB202G-043-053~058, 061 and 062; CB202G-044-053~062; CB202G-041-051 and 052; CB202G-042-051 and 052; CB202G-043-051 and 052; CB202G-044-051 and 052. American Welding Society (AWS) D1.5 2002 section 3.1.5 states, Welds shall be prohibited on the work except as follows:

During in process inspection this QA observed a Complete Joint Penetration (CJP) weld that did not appear to comply with the weld profile requirements of AWS D1.5 2002. The weld joint designation is FB204-042-064. The attached photo is for the purpose of capturing the in process workmanship being performed on this crossbeam.
